WINDOW/DOOR PROTOTYPE PRE-TESTING:

Case Study

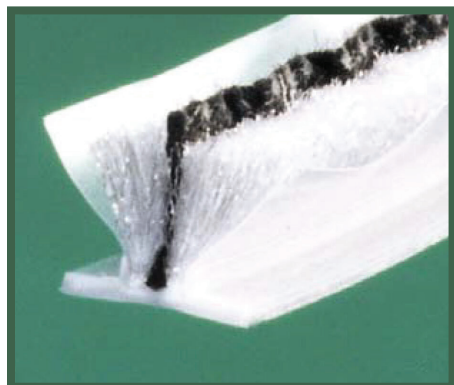
Air Testing

The pads and gaskets had good placement and were of sufficient size dimensioning. They did not interfere with operation but gave good protection in terms of air and water infiltration resistance.
